# INSPECTION REPORT

For the Property at:  
**123 YOUR HOME**  
KEMPTVILLE, ON K0G1J0

Prepared for: HOME BUYER  
Inspection Date: Thursday, October 24, 2013  
Prepared by: John Daigneault

Report No. 1090, v.4

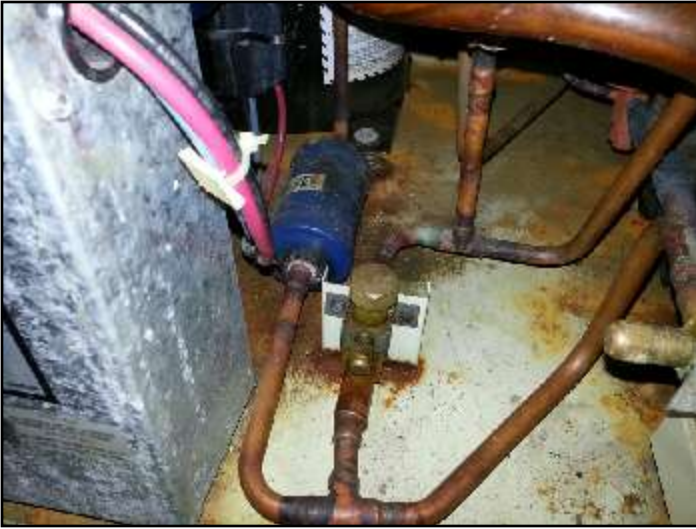
**Condition:** • [Corrosion](#)

rust noted in upper and lower cabinet. recommend full inspection by qualified contractor prior to close. system appears to be relying solely on electric backup

1. Corrosion

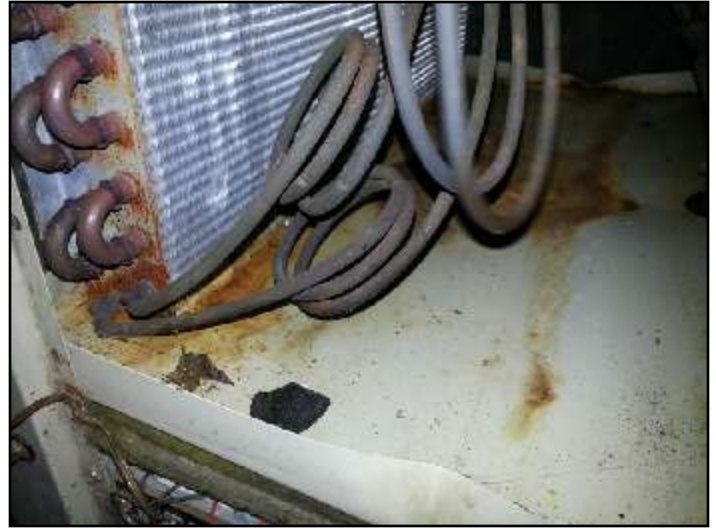
2. Corrosion

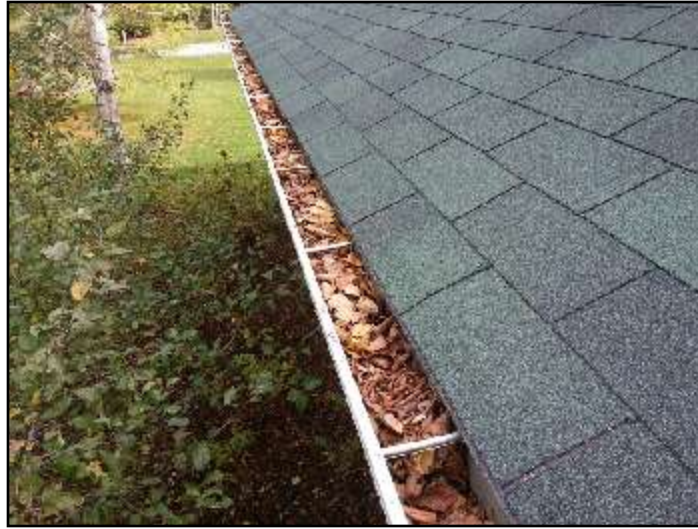
2. Condition: • [Clogged](#)

3. Clogged

Inspect and clean gutters in the spring and fall to promote good water flow from roof surface

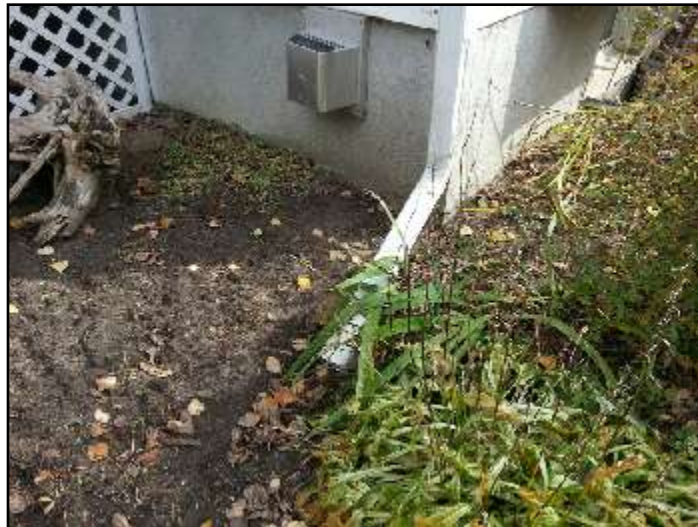
**3. Condition:** • Downspouts should be extended 6' from house to divert water away from foundation

**Implication(s):** Moisture close to foundation has a greater chance to enter basement through any foundation imperfections

4. Downspouts should be extended 6' from house...

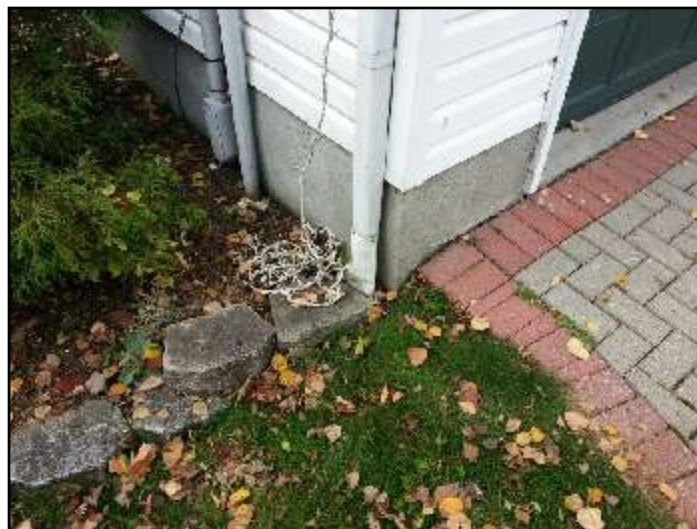
## 4. Condition: • [Downspouts discharging below grade](#)

End points of downspouts not visible can be an issue if they do not discharge away from the home

## 5. Downspouts discharging below grade

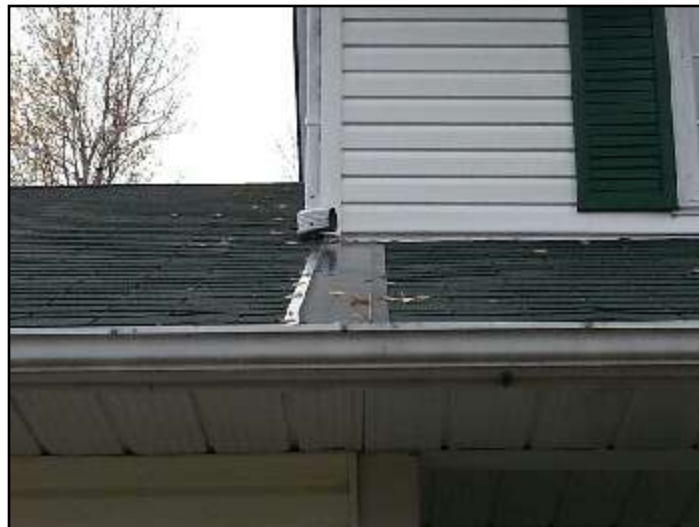
## 5. Condition: • [Downspouts discharging onto roofs](#)

extend downspout to lessen overshoot of rain water from upper roof and prematurely wear surrounding roof surface

## 6. Downspouts discharging onto roofs

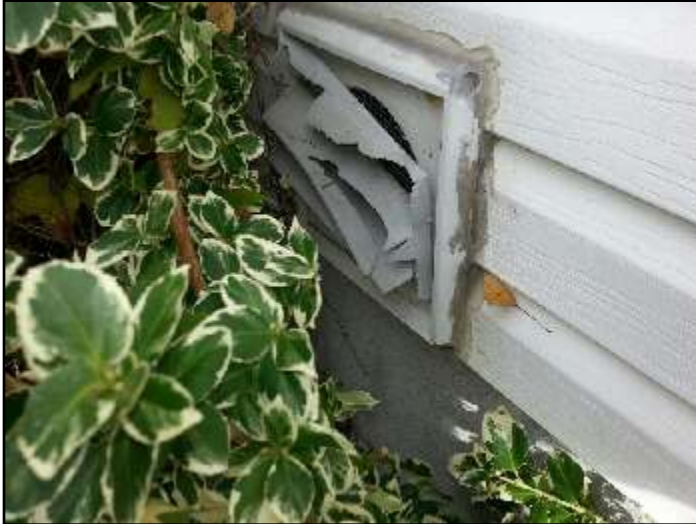
7.

**6. Condition:** • replace vent covers to reduce possible animal/insect entry

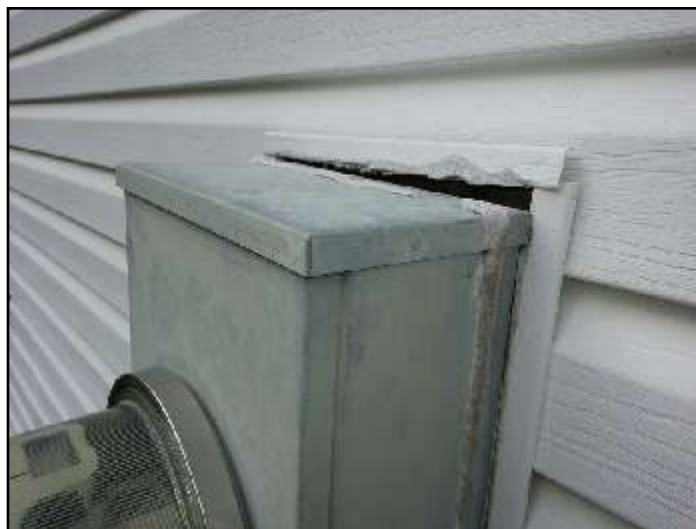
**7. Condition:** • [Caulking missing or ineffective](#)

meter needs to be secured and recaulked to reduce possible moisture entry/damage

9. *Caulking missing or ineffective*

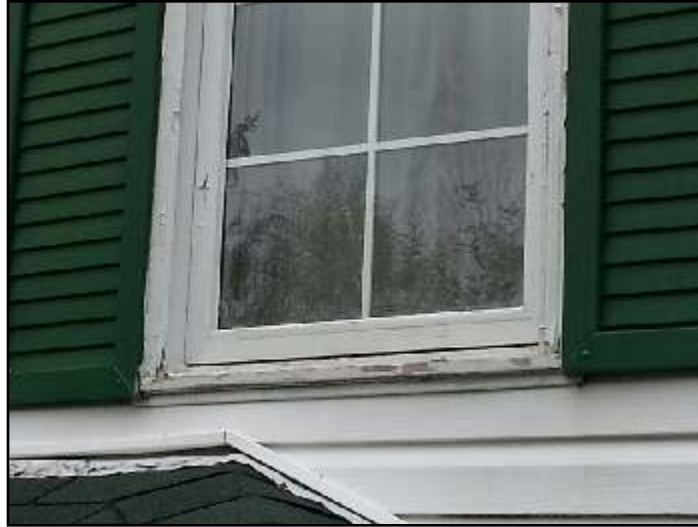
### 8. Condition: • [Paint or stain needed](#)

Some areas require attention to reduce deterioration of wood surfaces

10. *Paint or stain needed*

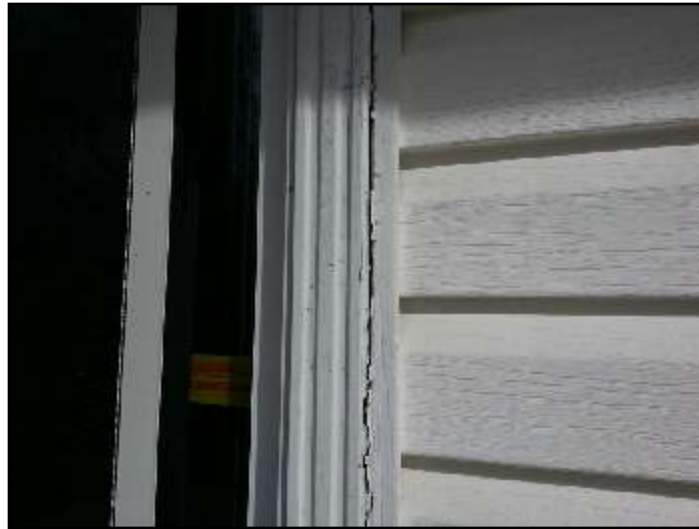
### 9. Condition: • [Caulking missing, deteriorated or loose](#)

some caulking improvements needed to reduce possibility of air/moisture infiltration

11. Caulking missing, deteriorated or loose

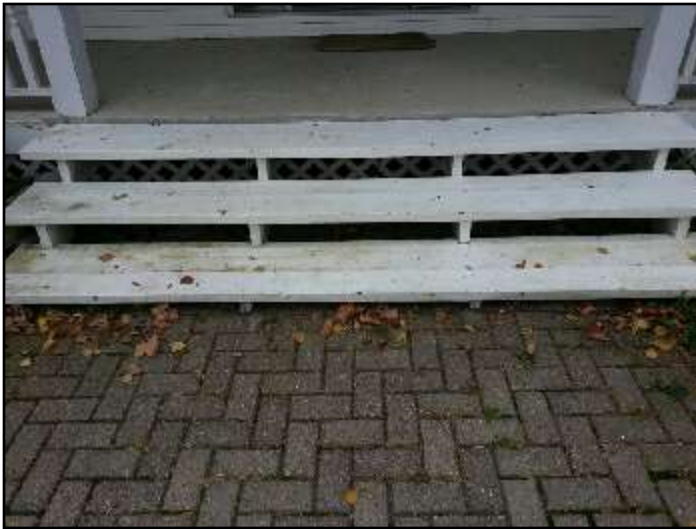
### 10. Condition: • [Stair rise too big or not uniform](#)

inconsistent step height - trip hazard

12. Stair rise too big or not uniform

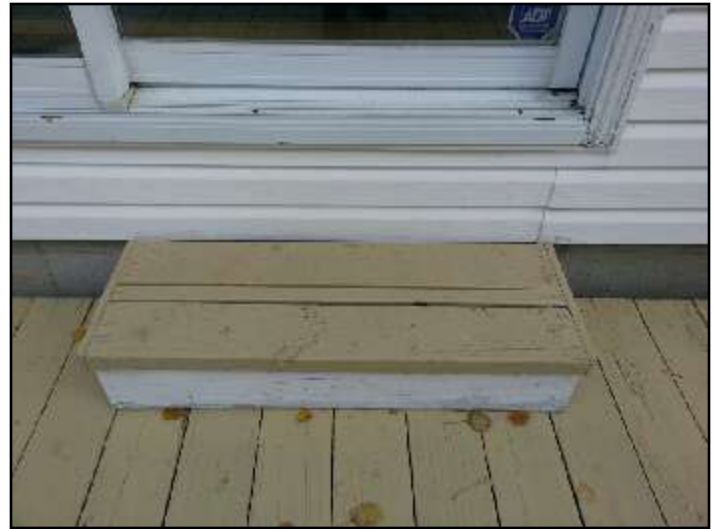
13. Stair rise too big or not uniform

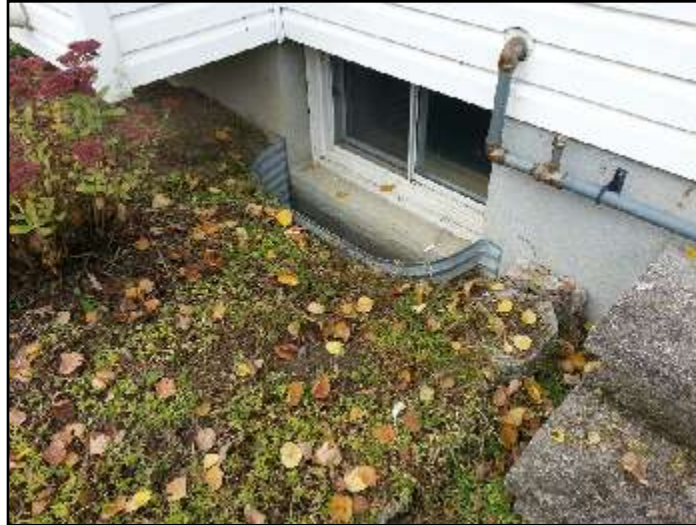
**12. Condition:** • Finished grade should allow for a 6" drop over 1st 10' to divert water away from foundation

**Implication(s):** Moisture collecting near the home have a greater chance of basement entry through imperfections in the foundation

**14.** *Finished grade should allow for a 6" drop...*

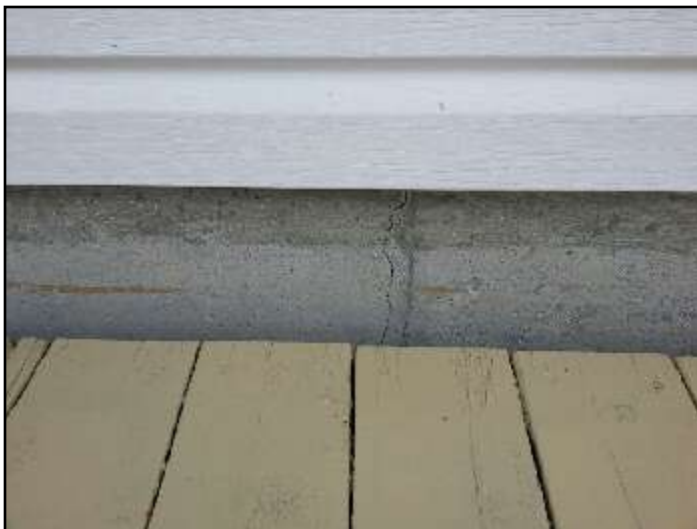
**13. Condition:** • Typical minor cracks

Minor cracks should be monitored and repaired as necessary to reduce chance of moisture entry into basement

15. Typical minor cracks

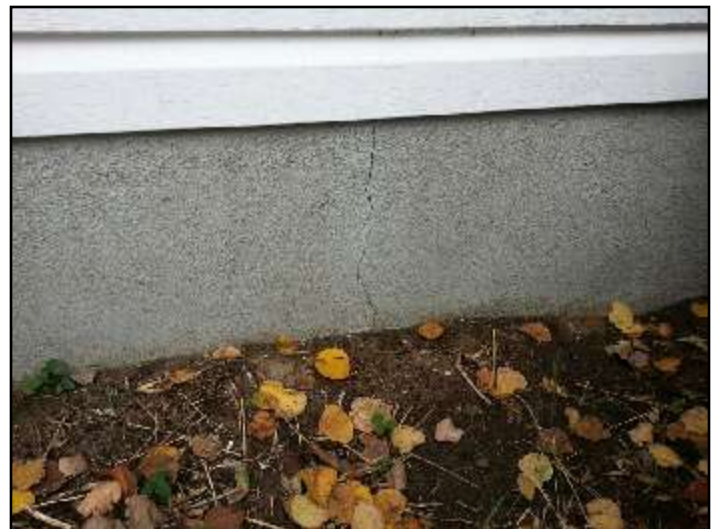
16. Typical minor cracks

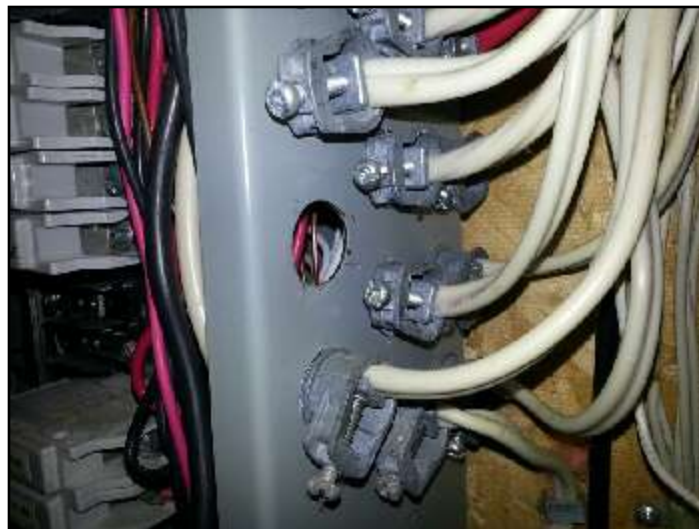
**14. Condition:** • [Unprotected openings](#)

repair to reduce possible animal entry - fire hazard

17. Unprotected openings

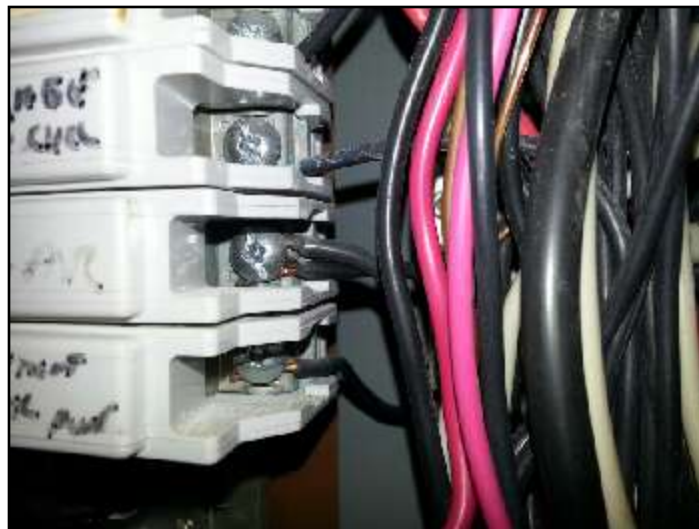
### 15. Condition: • [Double taps](#)

double tap noted - recommend repair by a licensed electrician to reduce possible fire hazard

18. Double taps

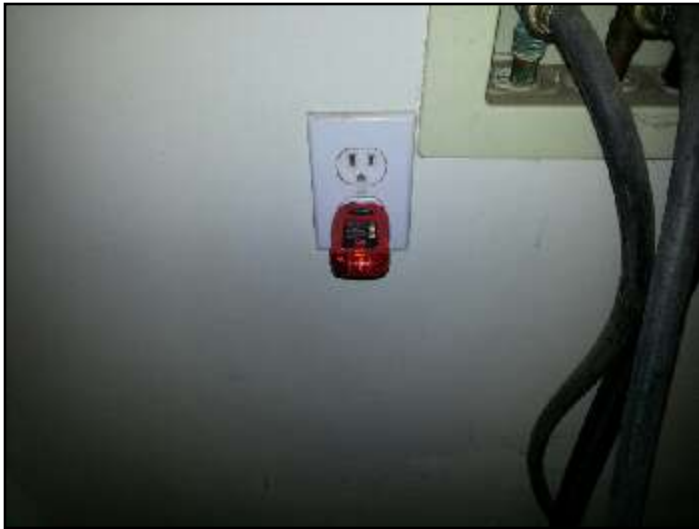
#### 16. Condition: • [Reversed polarity](#)

Electrical wiring misconfiguration - recommend repair by a licensed electrician

19. Reversed polarity

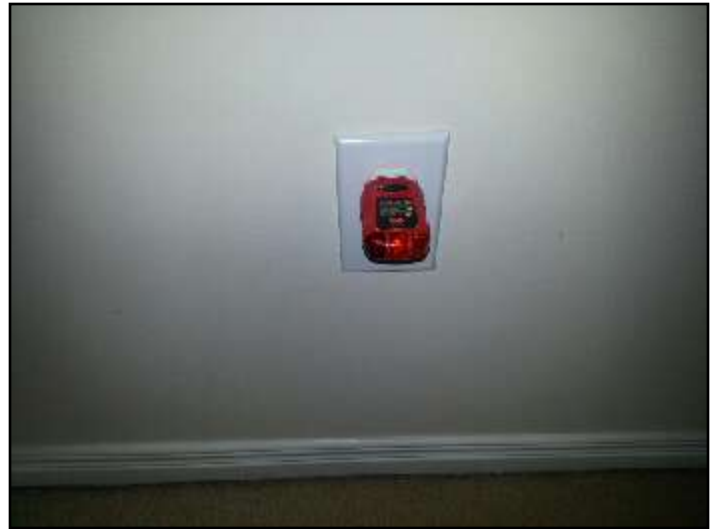
20. Reversed polarity

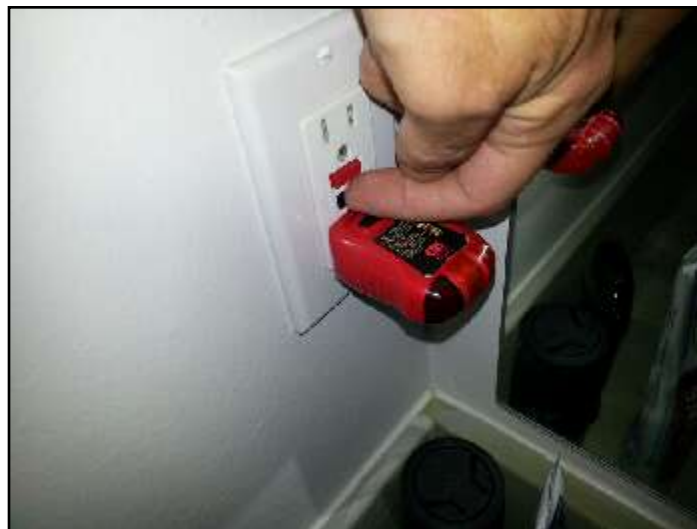
**17. Condition:** • [GFI test faulty](#)

Will not trip during GFCI test...manually pressing test button leaves outlet live

21. GFI test faulty

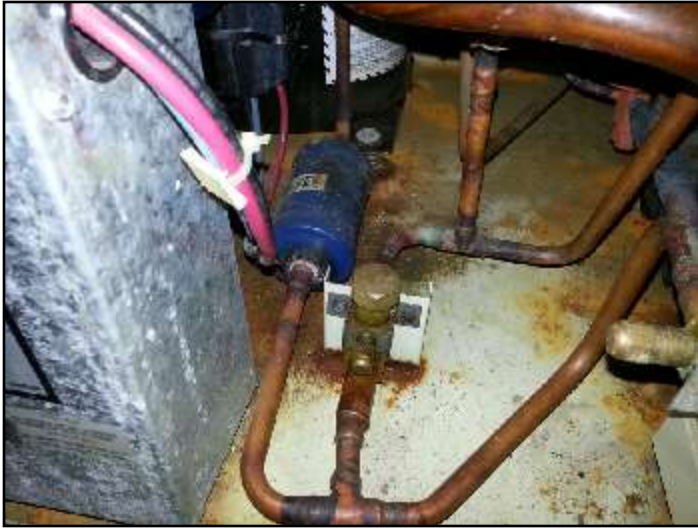
**23. Condition:** • [Corrosion](#)

rust noted in upper and lower cabinet. recommend full inspection by qualified contractor prior to close. system appears to be relying solely on electric backup

23. Corrosion

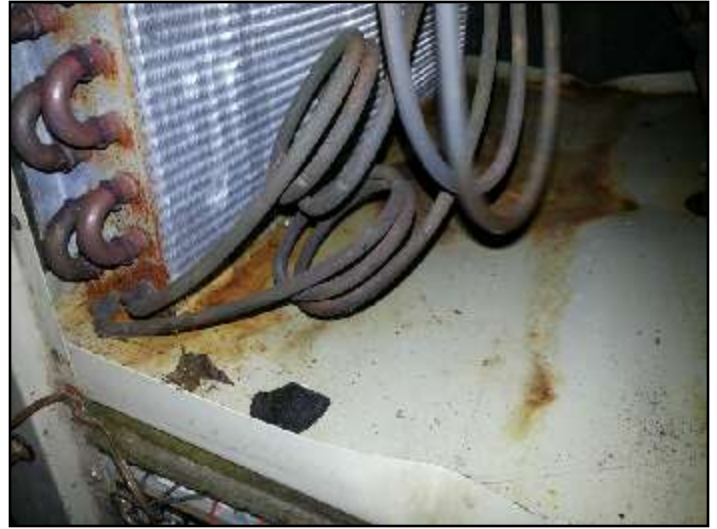
24. Corrosion

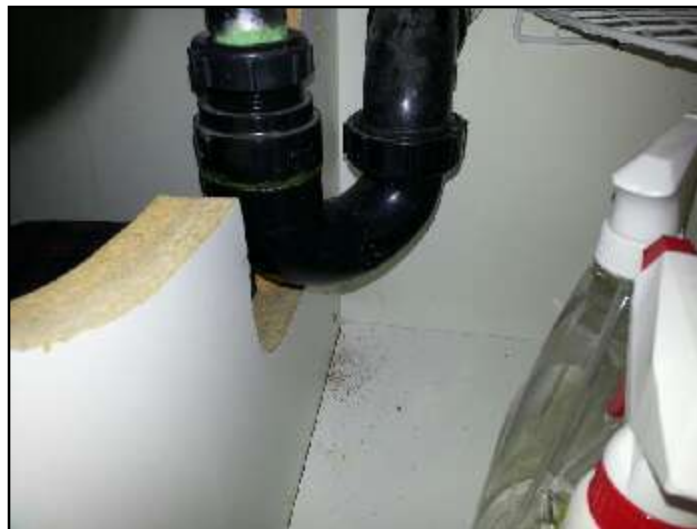
**24. Condition:** • [No clean out provision](#)

25. No clean out provision

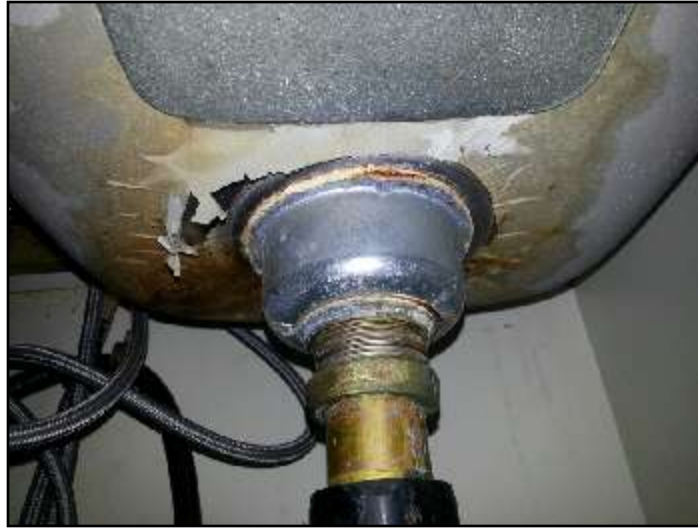
25. Condition: • [Leak](#)

26. Leak

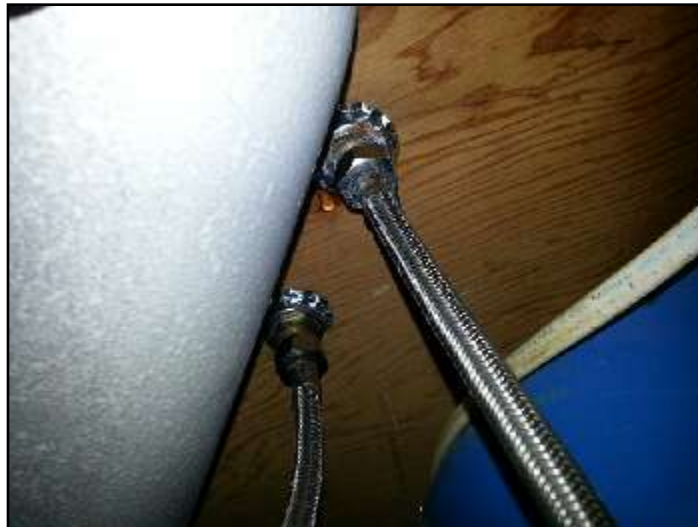
26. Condition: • [Drip, leak](#)

wet bar - cold side leak noted

27. Drip, leak

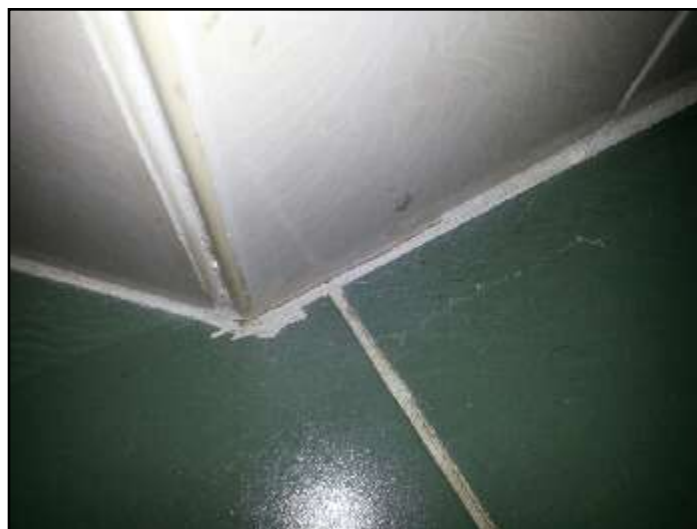
### 27. Condition: • [Caulking loose, missing or deteriorated](#)

upgrade caulking to reduce possible water damage to ceiling below

28. *Caulking loose, missing or deteriorated*

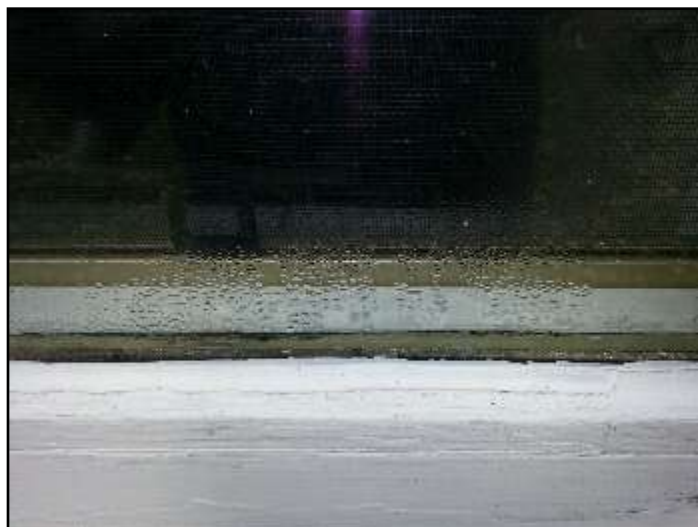
**28. Condition:** • [Lost seal on double or triple glazing](#)

thermal seal broken - repair/replace to reduce possible heat loss

**29.** *Lost seal on double or triple glazing*

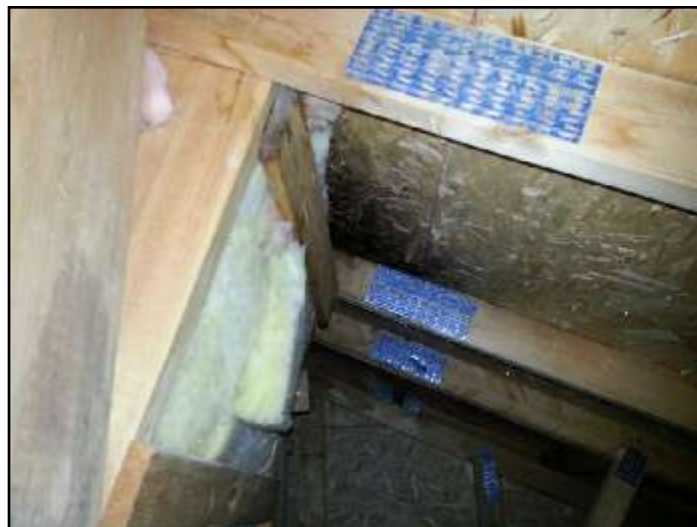
### 29. Condition: • [Leak](#)

Areas of moisture noted under roof sheathing. Recommend further review by a qualified roofer for cause and cost of repair

30. Leak

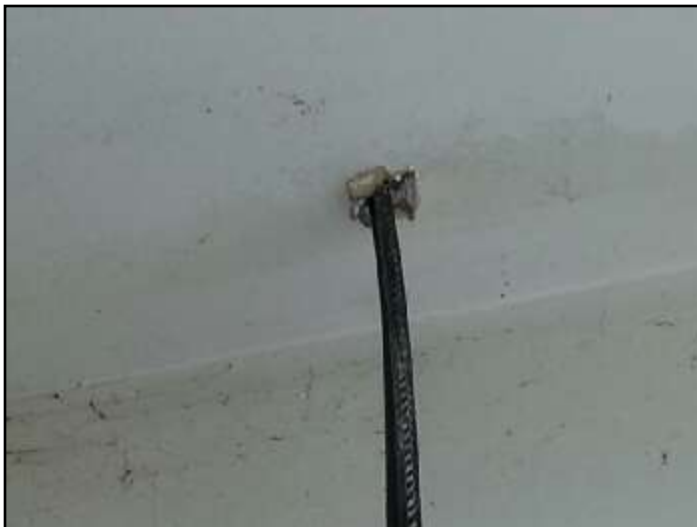
### **30. Condition:** • [Not gastight](#)

**31. Not gastight**

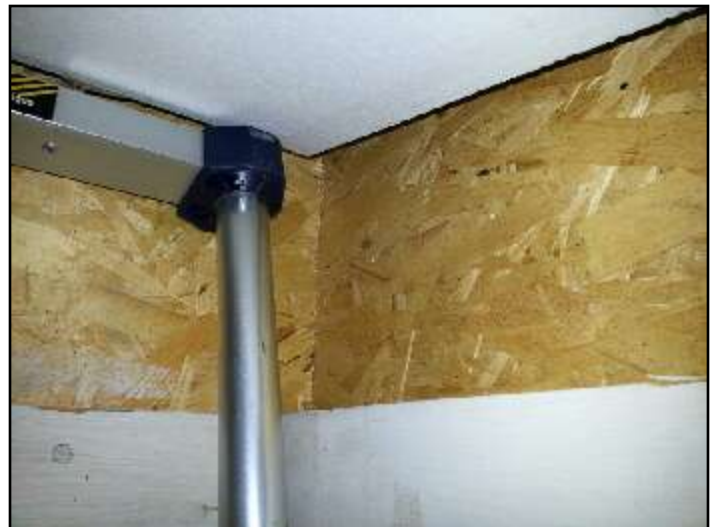
**32. Not gastight**

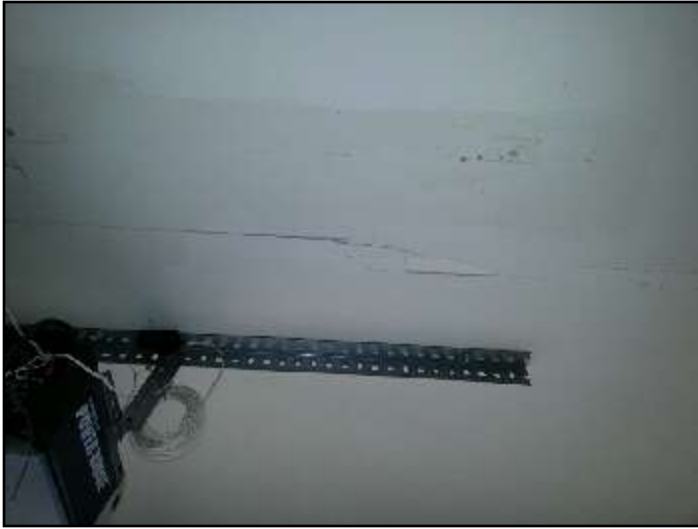
33. Not gastight

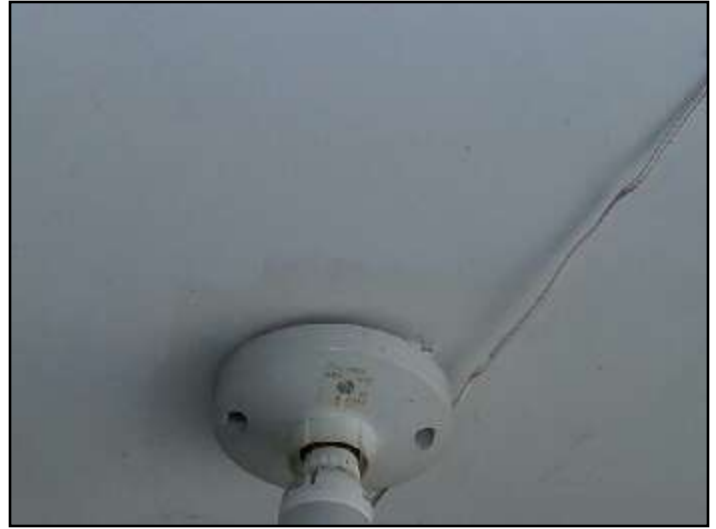
34. Not gastight

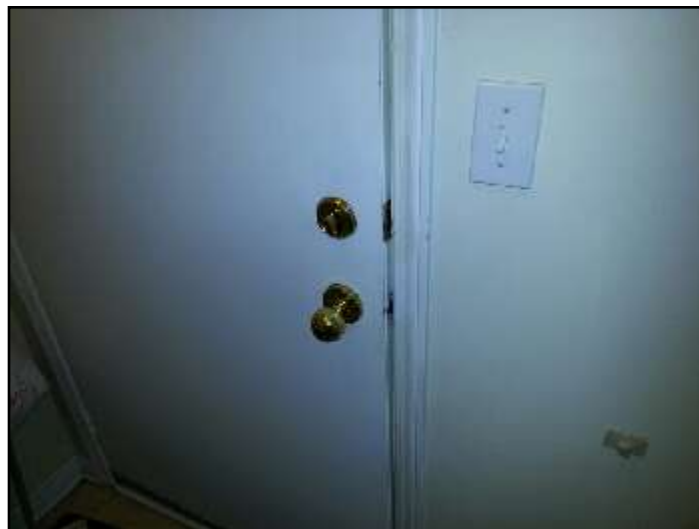
31. Condition: • [Does not close door fully](#)

35. Does not close door fully
