# INSPECTION REPORT

For the Property at:  
**123 YOUR HOME**  
KEMPTVILLE, ON K0G1J0

Prepared for: HOME BUYER  
Inspection Date: Thursday, October 24, 2013  
Prepared by: John Daigneault

Report No. 1090, v.4

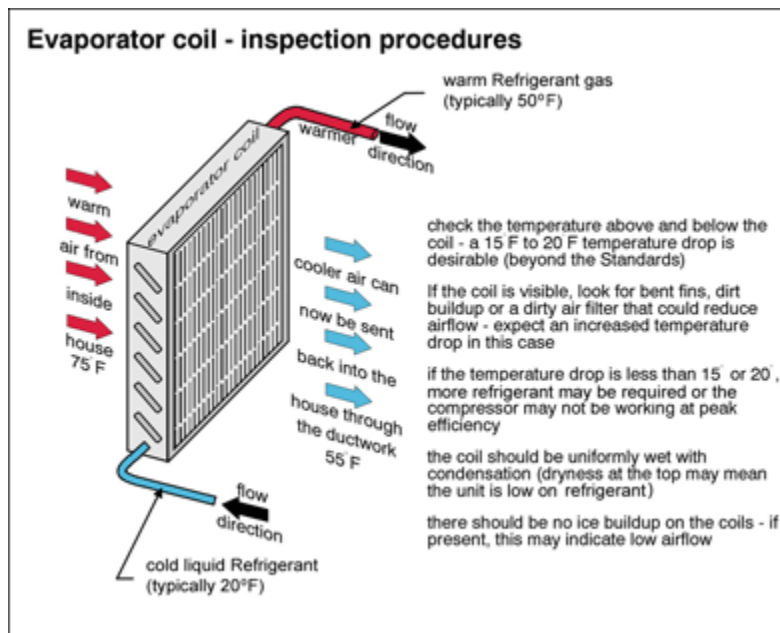
**Condition:** • [Corrosion](#)

rust noted in upper and lower cabinet. recommend full inspection by qualified contractor prior to close. system appears to be relying solely on electric backup

**Task:** Further evaluation

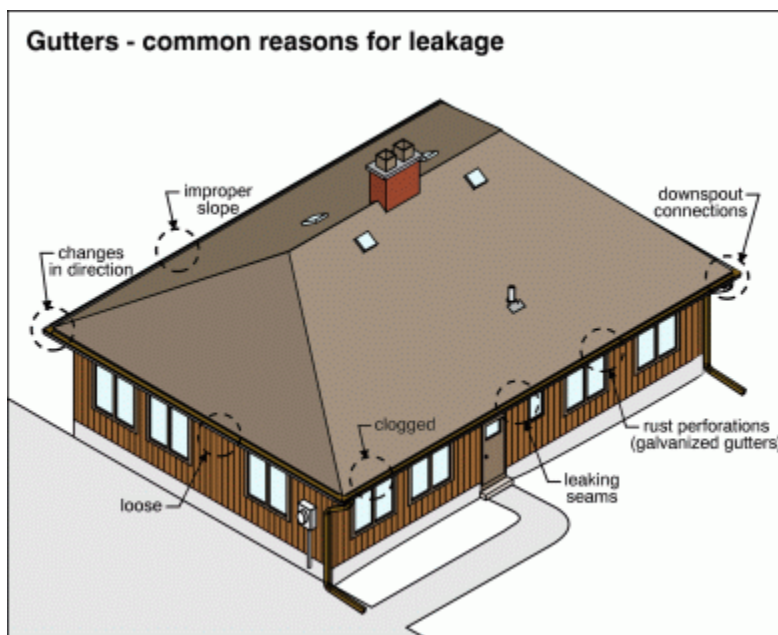
2. Condition: • [Clogged](#)

**Implication(s):** Chance of water damage to contents, finishes and/or structure

**Task:** Clean

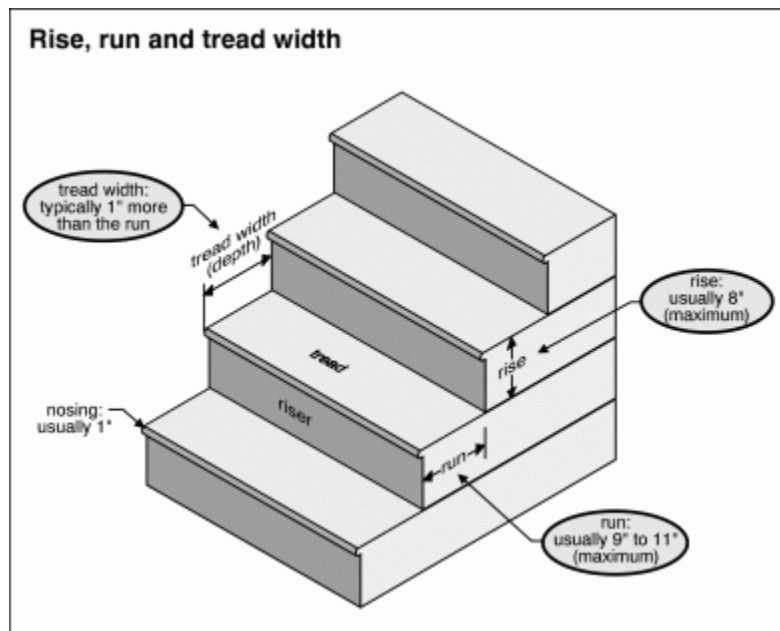
### 10. Condition: • [Stair rise too big or not uniform](#)

inconsistent step height - trip hazard

**Implication(s):** Trip or fall hazard

**Task:** Repair or replace

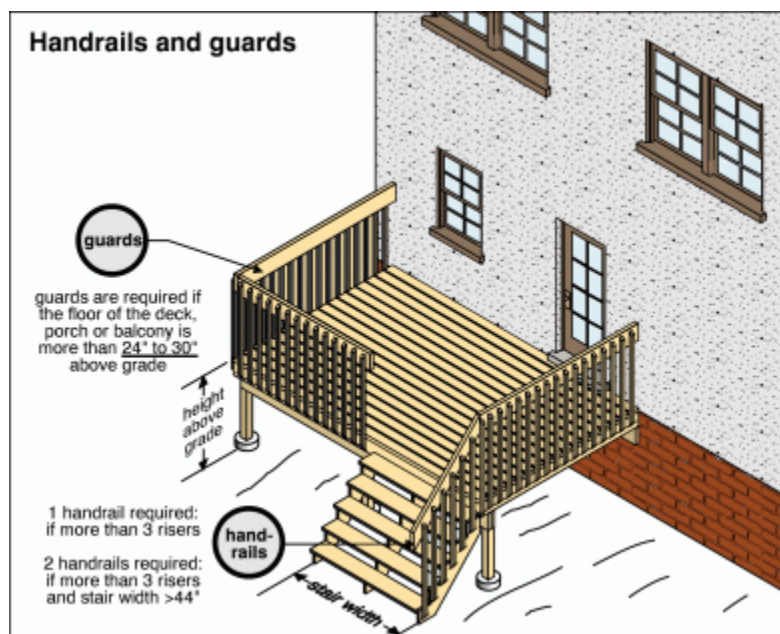
### 11. Condition: • [Missing](#)

**Implication(s):** Fall hazard

**Task:** Provide

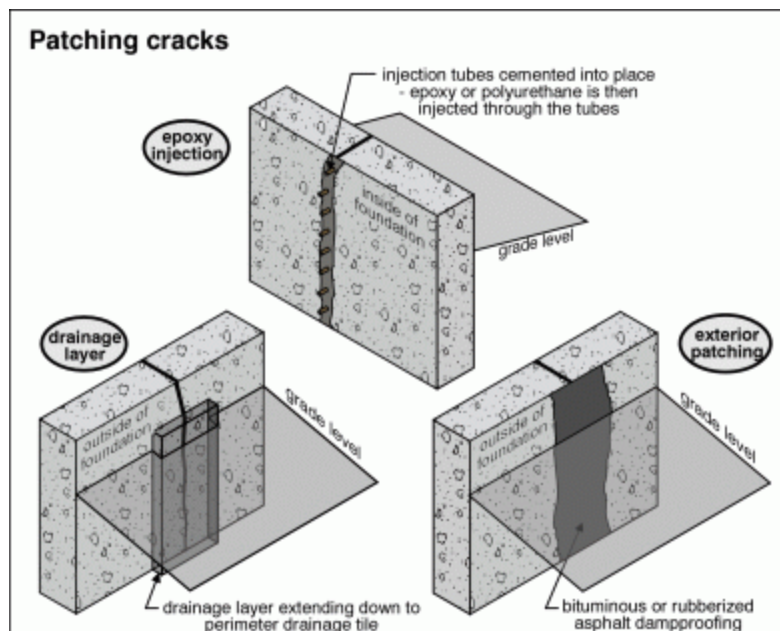
**13. Condition:** • Typical minor cracks

Minor cracks should be monitored and repaired as necessary to reduce chance of moisture entry into basement

**Task:** Monitor

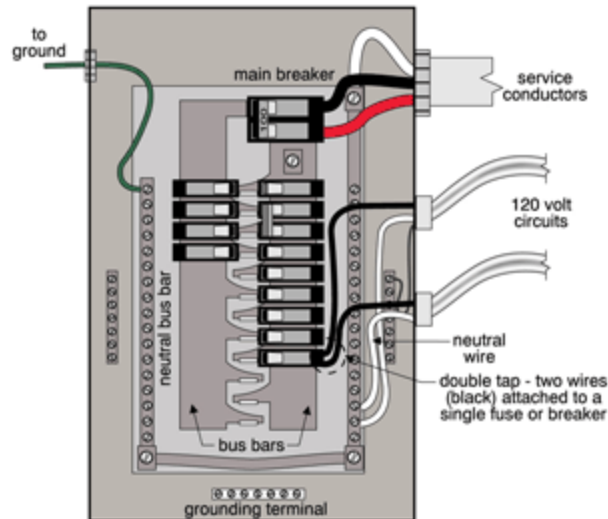
### 15. Condition: • [Double taps](#)

double tap noted - recommend repair by a licensed electrician to reduce possible fire hazard

**Implication(s):** Fire hazard

**Task:** Repair

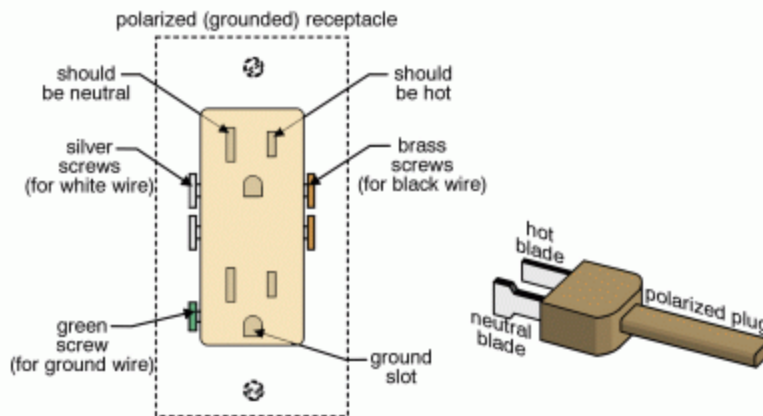
#### 16. Condition: • [Reversed polarity](#)

Electrical wiring misconfiguration - recommend repair by a licensed electrician

**Task:** Repair

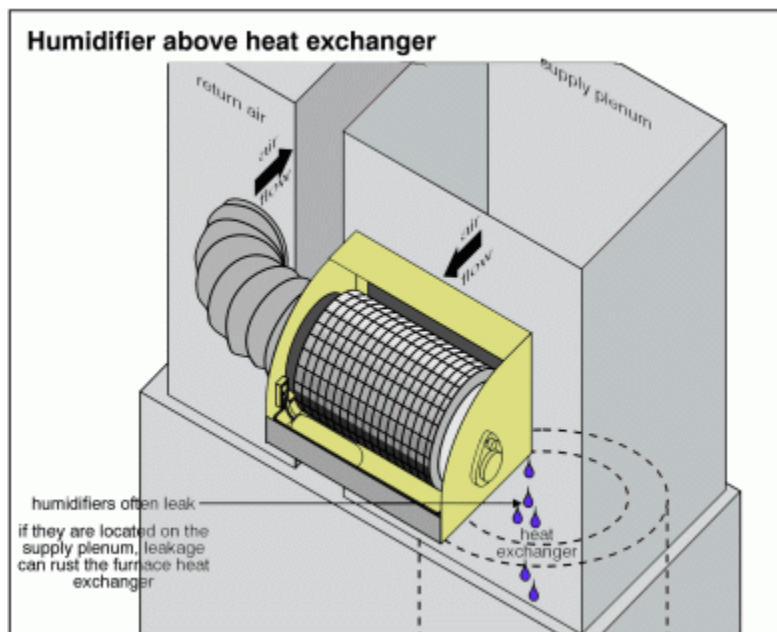
### **20. Condition:** • [Leak](#)

Humidifier appeared disconnected and not in use. Verify operation with vendor

**Task:** Request disclosure
